International Journal of Applied Dental Sciences

A reason to smile

Case Report

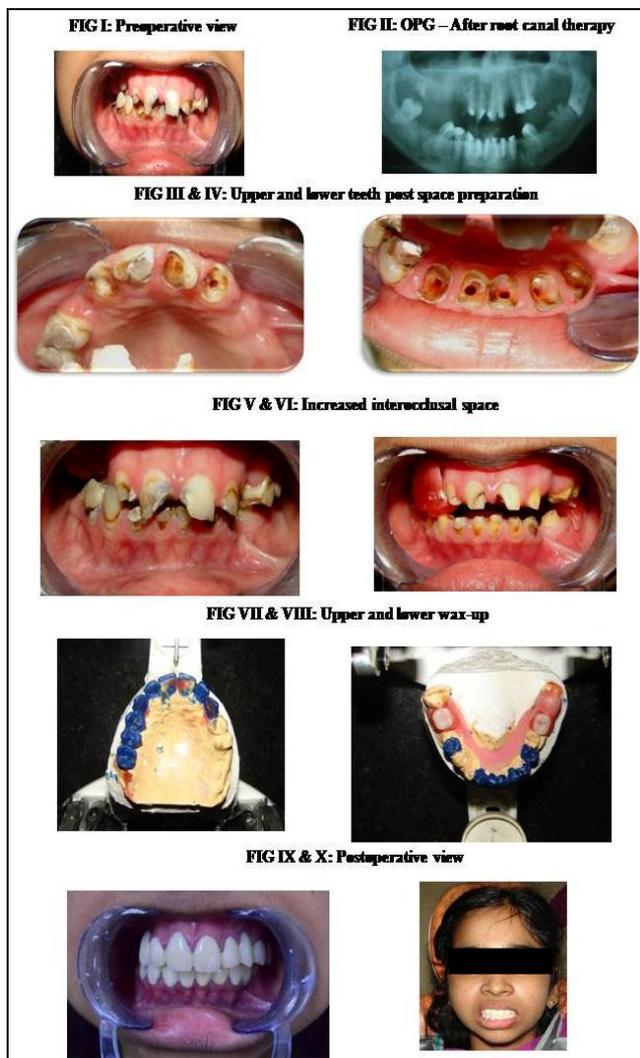
A 20-year-old female patient reported to the department of conservative dentistry and endodontic with chief complaint of difficulty in chewing, restricted mouth opening and poor appearance of her existing upper and lower dentition with an unpleasant smile. The medical history presented with a history of rheumatoid arthritis for which she is undergoing treatment since childhood. Intra-oral examination revealed grossly destructed tooth structure with missing upper and lower posterior teeth (FIG I). After thorough examination, OPG was taken and the treatment protocol was explained to the patient in detail. After informed consent, endodontic therapy was carried out in 12, 11, 21, 22, 24, and 25 in the upper arch and in the mandibular arch root canal therapy was performed in 35, 34, 33, 32, 31, 41, 42, 43, 44 and 45 in multiple visits (FIG II).

(Reforpost, Angelus, Brazil) was luted in place with Multilink resin cement (Ivoclar Vivadent) and core build up was done with Z 350 (3M). On her next consecutive appointment, tooth preparation of both upper and lower teeth was done. Following tooth preparation, bite registration was done (EXABITE II; GC Corp, Tokyo, Japan) (FIG V & VI).

Then the patient's centric relation was recorded using UTS face bow and the recorded relation was transferred to a semi-adjustable articulator (Stratos 300). Mock wax up was done. The temporary prosthesis was fabricated with heat cure acrylic and polished (FIG VII & VIII). The patient's tooth preparation was temporized for 2-3 weeks. After 3 weeks of temporization, final impression was taken. Repeat bite and centric relation was recorded for confirmation. Then the final prosthesis, porcelain fused ceramic bridge was processed and luted with glass ionomer cement (FIG IX & X). It is 6 months since the completion of the treatment and the patient is very happy with the outcome of the treatment.
