ISSN Print: 2394-7489
ISSN Online: 2394-7497
IJADS 2019; 5(2): 484-487
© 2019 IJADS
www.oraljournal.com
Received: 16-02-2019
Accepted: 18-03-2019

Dentinal crack formation during root canal preparations by three different reciprocating single file systems: An *in vitro* study

Dr. Ab Wahid Zargar, Dr. Malik Sartaj, Dr. Riyaz Farooq, Dr. Aamir Rashid Purra and Dr. Fayaz Ahmad Ahanger

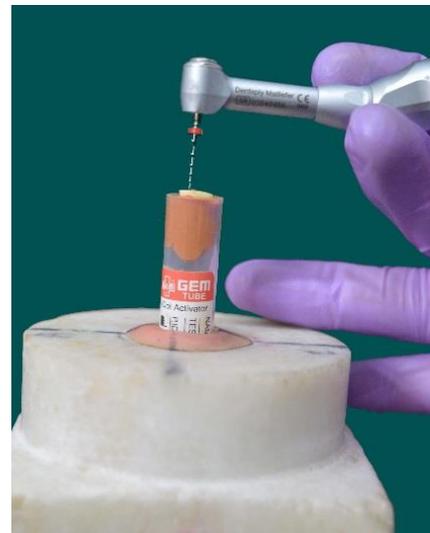
Fig 1: Simulation of periodontal ligament by silicone impression (blue arrow) material and customized jig for standardization of instrumentation (white arrow)

The working length was established by subtracting 1 mm from the length of a size 10 K-file inserted into the canal until the tip of the file became visible at the apical foramen. The periodontal ligament was simulated using addition silicone impression and fixing the teeth in blood sample collecting tubes with it¹¹. A working jig (fig 1) was constructed to hold the tubes containing teeth to standardize the instrumentation.

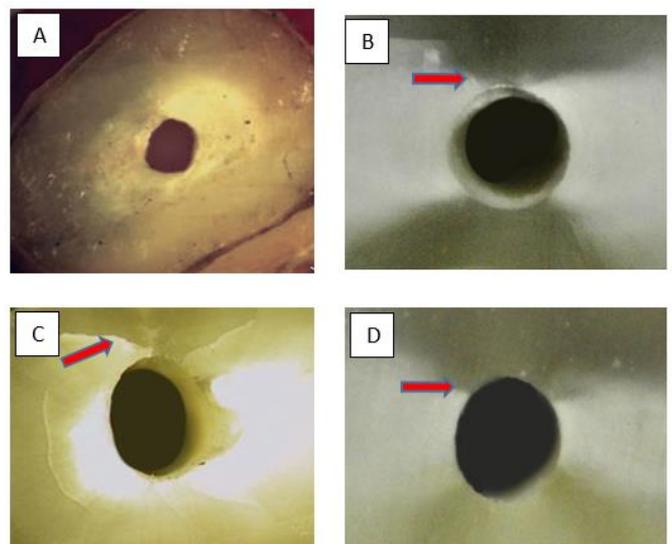
Fig 2: Microscopic cross sections from each experimental group at the 6-mm level (A–D) at 80X magnifications. Red arrows indicate dentinal defects. (A) Control, (B) Reciproc (C) WO Primary, (D) WOG.

All the roots were horizontally sectioned at 3, 6, and 9 mm from the apex with diamond disc at low-speed under water cooling. The slices were then analyzed using a stereomicroscope (Kyowa Getner, Japan). The samples were photographed with a reflex camera (Nikon D90; Nikon Tokyo, Japan) attached to the stereomicroscope at a magnification of 24x and 80x to determine the presence of Microcracks

A crack was defined as only defects originating from the inner root canal space. All other defects that did not originate from the canal wall as craze lines were not considered cracks (Fig. 2). Roots were classified as cracked if at least 1 of the 3 sections obtained from each root showed even 1 crack^[16].
